Baltoflake: Saving steel beyond 30 years

Proven maintenance free steel protection in the splash zone

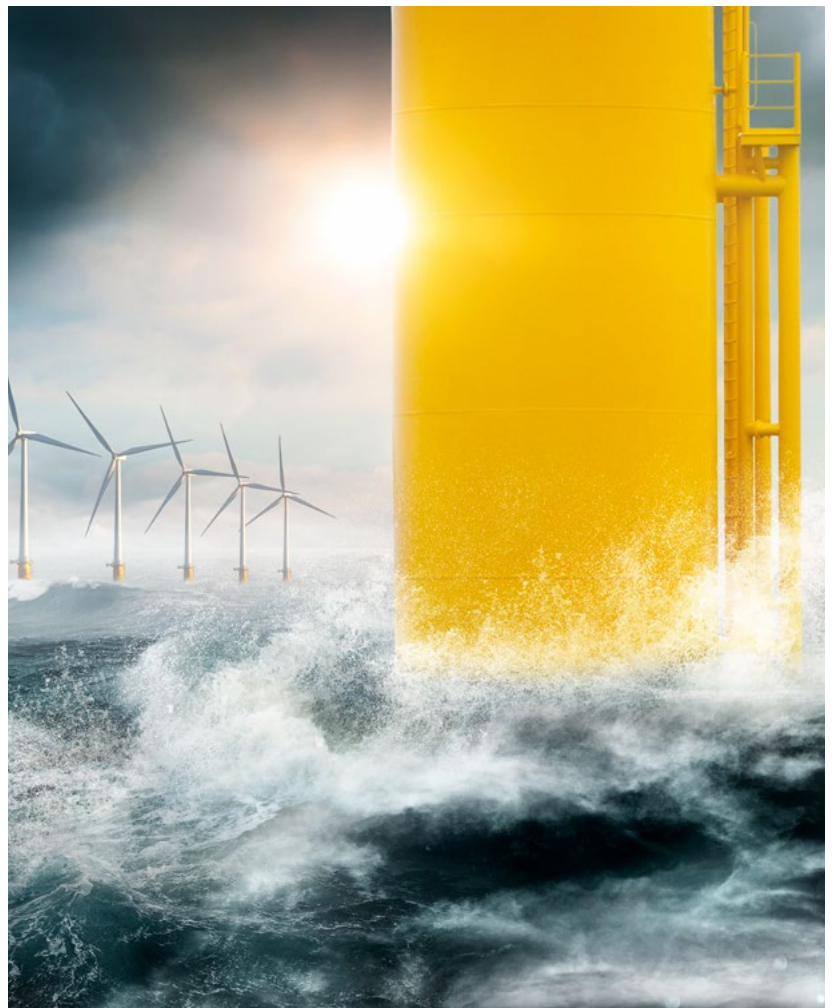
In the study, DNV inspected a section of jacket from a North Sea oil platform which was installed in 1972 and decommissioned in 2020. Jotun's Baltoflake coating was applied to the platform in the late 1980s and, despite over 30 years' exposure to the North Sea's harsh environment, analysis revealed that the coating at the splash zone was intact, still smooth and showing no signs of delamination.

- A visual inspection of the North Sea oil platform steel revealed that the coating at the splash zone was intact, still smooth and showing no signs of delamination after more than 35 years in the North Sea.

- Further examinations were carried out on a 4m section of the North Sea oil platform steel brace and examined at DNV's lab. The general condition of the coating was good, with good fitting to the rugged surface. No blistering, rust, cracks or other visual defects were observed.
